# Success with Molub-Alloy 777 in Dragline Bearings

## PHOSPHATE MINING (USA)

Dragline drag, hoist & fairlead bearings

Castrol Molub-Alloy® 777-1 ES grease

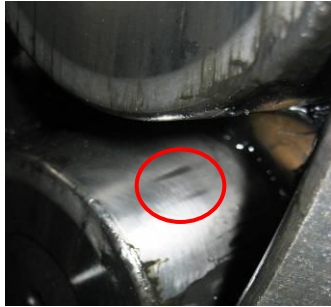
Fretting wear marks are present as shown in red.

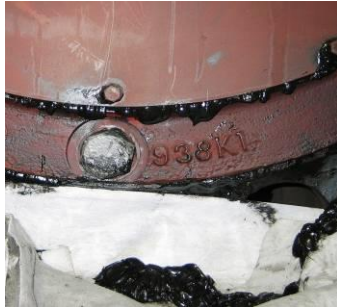
Grease appears too soft and running out of bearing.

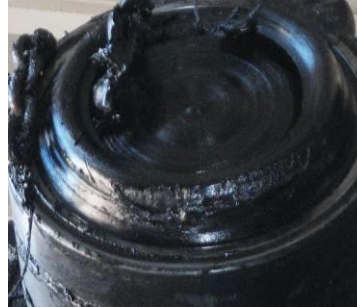
Grease is very hard like rubber material.

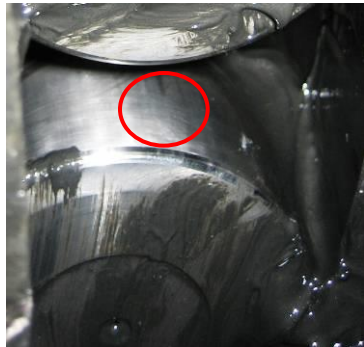
Fretting marks less visible. Same bearing area shown in red.

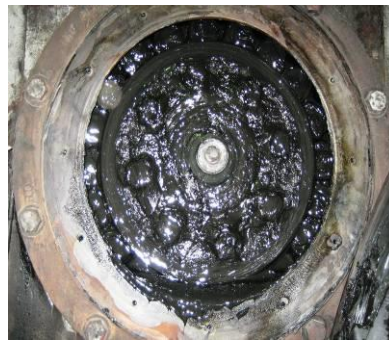
Bearings are sufficiently lubricated. Grease is not running out.

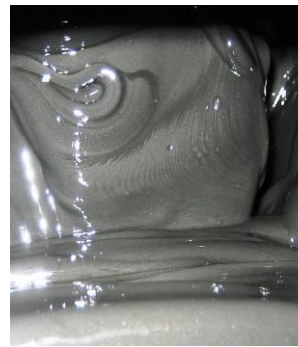
Grease appearance and consistency like new.
