# Optigear Synthetic X Performance is 'Like New' After Two Years

## WIND AFTERMARKET (DENMARK)

Wind Turbine Gearboxes

Castrol Optigear® Synthetic X 320

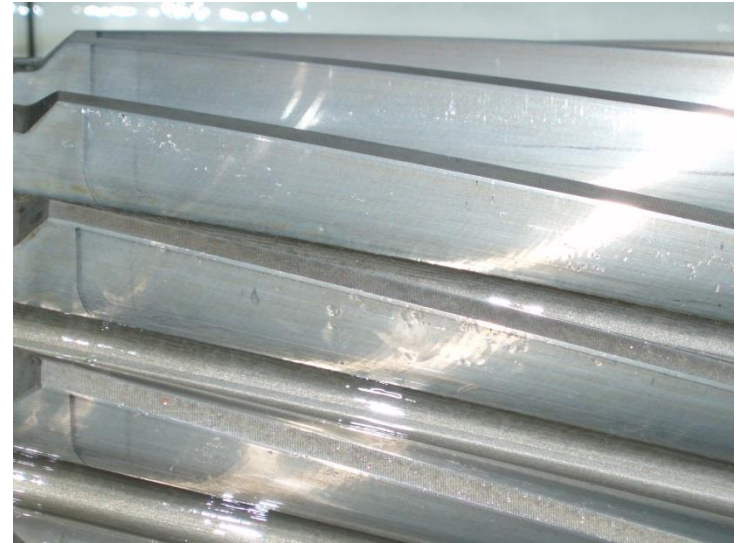
The gears at the end of the field trial show excellent condition with little or no wear detected.

Intermediate stage gear  
End of field trial

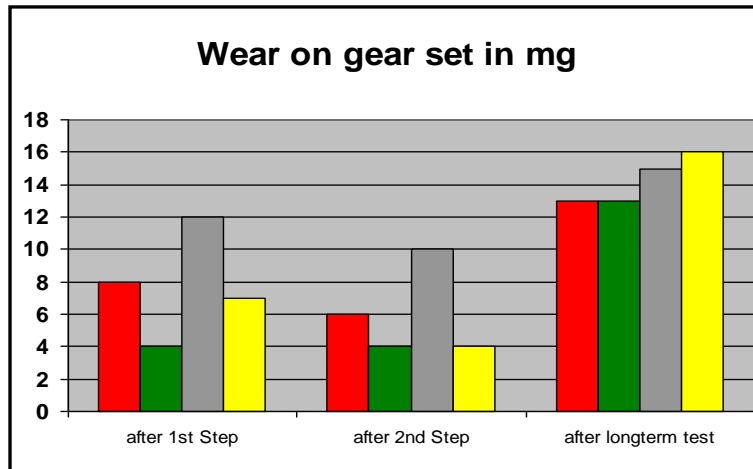
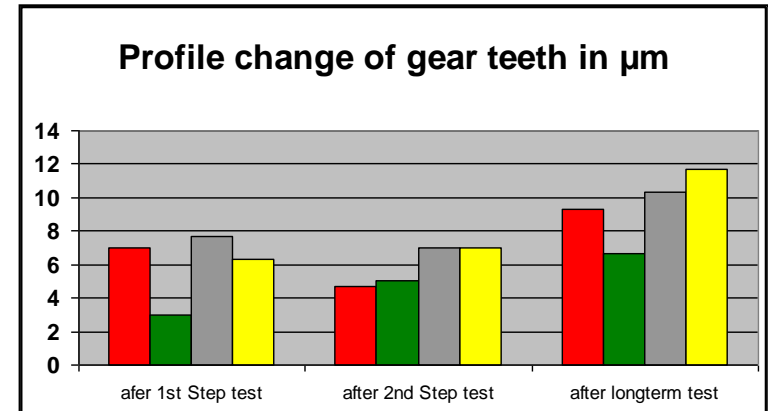
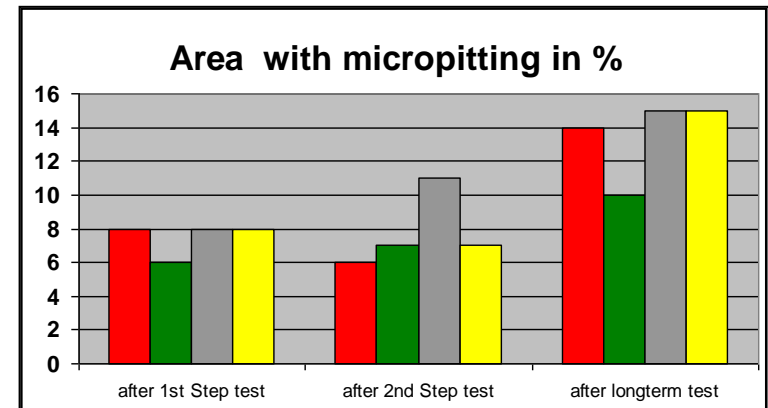
Additional details of the FZG Micropitting test (FVA-54) are shown here.

After the two-year field run, Optigear Synthetic X 320 was checked in key gear oil performance tests. These include the FVA-54 test which determines the micro-pitting resistance of the oil, FE-8 test which determines the wear protection for the bearings, and the FZG test which determines the extreme pressure (anti-scuffing) protection for the gears.

Test criteria	New Oil	Two-Year Test Oil
FZG Micropitting test @ 90 °C (FVA-54)	> 10 stages GFT-classification: High	> 10 stages GFT-classification: High
FZG Micropitting test @ 60 °C (FVA-54)	> 10 stage GFT-classification: High	> 10 stages GFT-classification: High
FE-8 Bearing wear at boundary lubrication (FE8-80h; 7.5/100-80)	Mw50 < 1 mg Mk50 = 1.8 mg Mrb = 22.9 Nm No rippling nor micropitting	Mw50 < 1 mg Mk50 = 4.1 mg Mrb = 23.1 Nm No rippling nor micropitting
FE-8 Bearing fatigue in mixed friction condition (FE8-800h; 75/100-70)	Mw50 = 16 mg Mrb = 21.3 Nm 800 hours w/o failure	Mw50 = 17 mg Mrb = 22.7 Nm 800 hours w/o failure
FZG Test (double speed, A/16.6/90)	> 12 stages	> 12 stages
